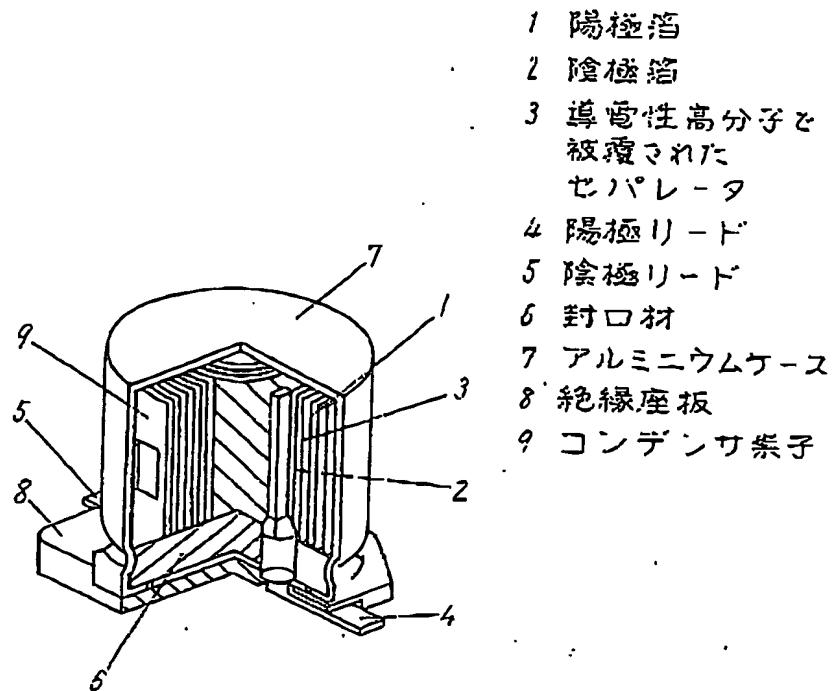
Fig. 1

- 1 陽極箔
- 2 陰極箔
- 3 導電性高分子と被覆されたセパレータ
- 4 陽極リード
- 5 陰極リード
- 6 封口材
- 7 アルミニウムケース
- 8 絶縁座板
- 9 コンデンサ素子

- 1 Anode Foil
- 2 Cathode Foil
- 3 Separator Coated with Electroconductive Polymer
- 4 Anode Lead
- 5 Cathode Lead
- 6 Sealant Member
- 7 Aluminium Case
- 8 Insulation Seat
- 9 Capacitor Device
